# NAVAL POSTGRADUATE SCHOOL Monterey, California

COMBAT DAMAGE ASSESSMENT TEAM

A-10/GAU-8 LOW ANGLE FIRINGS

VERSUS
SIMULATED SOVIET TANK COMPANY (ARRAY 17)
(LAVP Lot Number AJD 79A181-001, AEROJET)

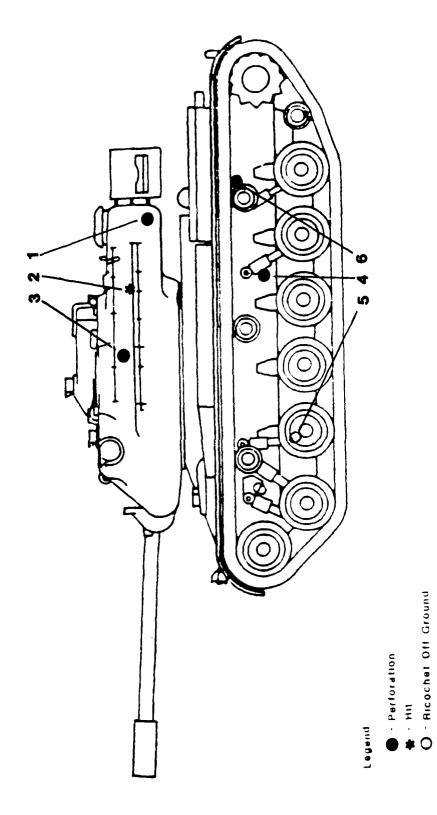
FIGURE 7. Impact Diagram, Tank 38.

100% M-Kill and 95% F-Kill resulting from the following observed effects (Figure 7):

- a. M-Kill: The assessment of 100% M-Kill is based on perforation 3 (Figure 8) through the turret which caused 3 crew casualties, perforation 4 through the left fuel cell near the bottom, and perforation 6 (Figure 9) through the left side of the engine compartment with damage to major engine components, e.g., oil cooler and carburetor.
- b. F-Kill: The assessment of 95% F-Kill is based on perforation 3 which caused fragment and spall impacts on crew manikins. Examination of manikin damage supports a view that the tank commander (Figure 10 and 11) and loader (Figure 12) were killed and the gunner (Figure 13) seriously wounded.

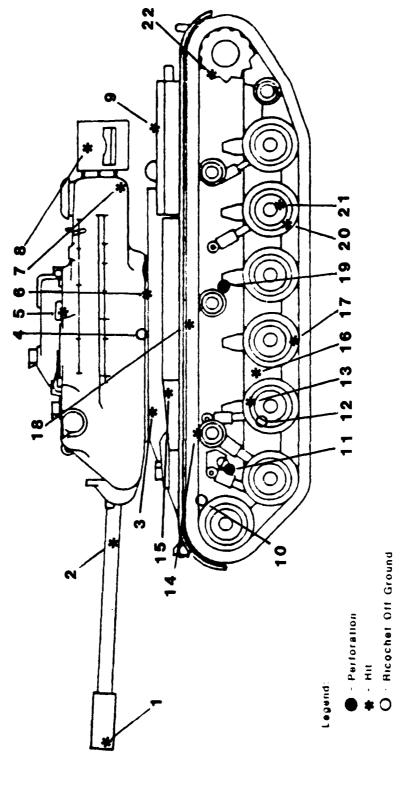
FIGURE 14. Impact Diagram, Tank 41.

100% M-Kill and 40% F-Kill resulting from the following observed effects (Figure 14):

b. F-Kill: The assessment of 40% F-Kill is based on impact 1 (Figure 16) which perforated one wall of the bore evacuator and gun tube, and impact 11, which degraded the firepower of the tank through crew casualties.

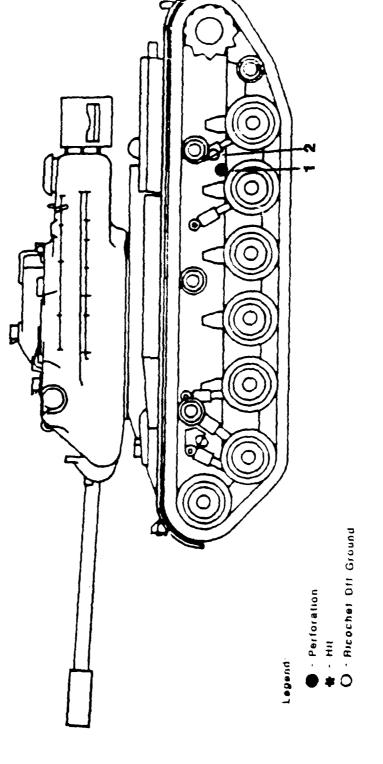
FIGURE 17. Impact Diagram, Tank 34.

100% M-Kill resulting from the following observed effects (Figure 17):

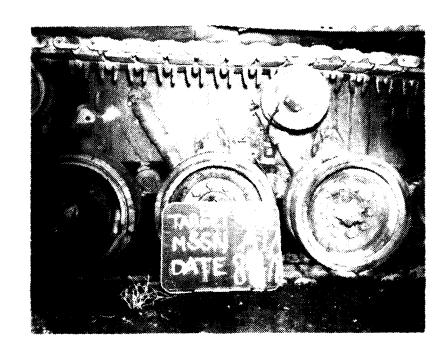
FIGURE 18. Impact 1, Tank 34 Hull Perforation.

An assessment of 100% M-Kill is based on impact number 1, which perforated the left side of the hull and penetrated into the left fuel cell (Figure 18). The hazard represented by the fuel running into the floor of the engine and fighting compartments would have to be mastered by the crew immediately.

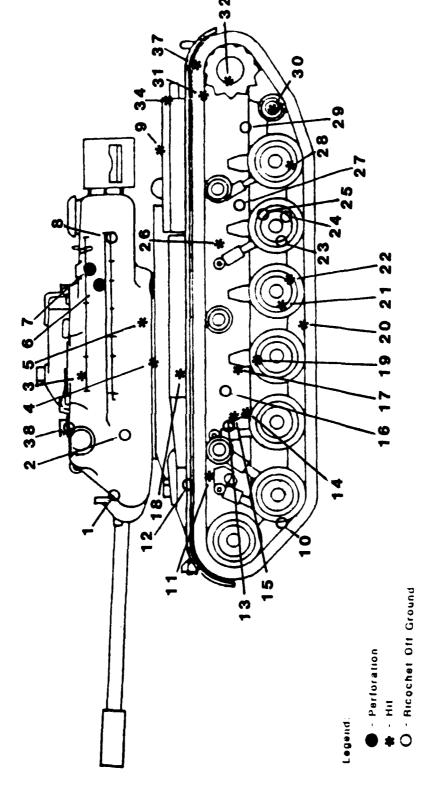
FIGURE 19. Impact Diagram, Tank 4.

90% M-Kill and 100% F-Kill resulting from the following observed effects (Figure 19):

- a. M-Kill: The assessment of 90% M-Kill is based on impacts 6 and 7, which incapacitated the tank commander, gunner, and loader, and impacts 13, 20, 22, 24, 25, 30, and 31, which caused significant cumulative damage to the track and suspension system (Figures 20 and 21).
- b. F-Kill: The assessment of 100% F-Kill is based on impact 4, which jammed the turret and impacts 6 and 7, which perforated the left side of the turret killing the tank commander (Figure 22) and wounding the gunner and loader, as assessed from fragment damage to crew manikins.

NOTE: Hits 35, 36 and 37 are on the front of the tank.
These hits are considered insignificant and are not shown.

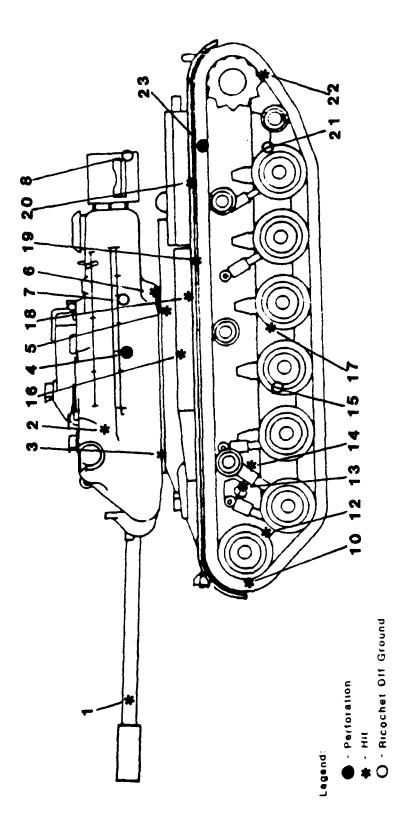
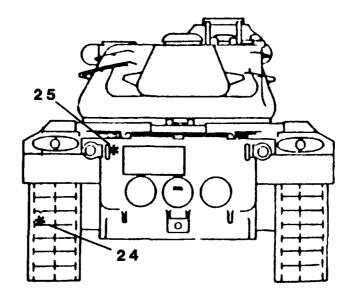
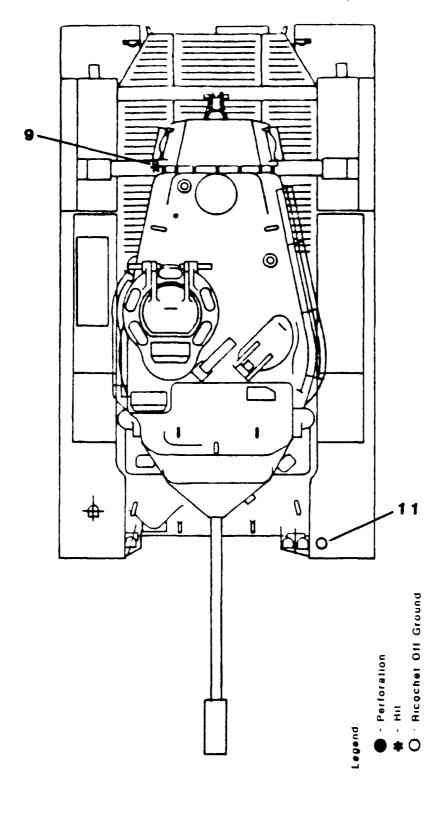
100% M-Kill and 100% F-Kill resulting from the following observed effects (Figures 23, 24, and 25):

- a. M-Kill: The assessment of a 100% M-Kill is based on impact 23 which perforated the left hull and penetrated 3 valve covers and the oil cooler and on minor damage to the track and suspension system caused by impacts 10, 13, and 15.
- b. F-Kill: The assessment of a 100% F-Kill is attributed to impacts 1, 3, and 6 which jammed the turret and penetrated the gun tube, and to crew casualties (gunner & loader) caused by impact 4 which perforated the left turret into the fighting compartment (Figures 26 through 28):

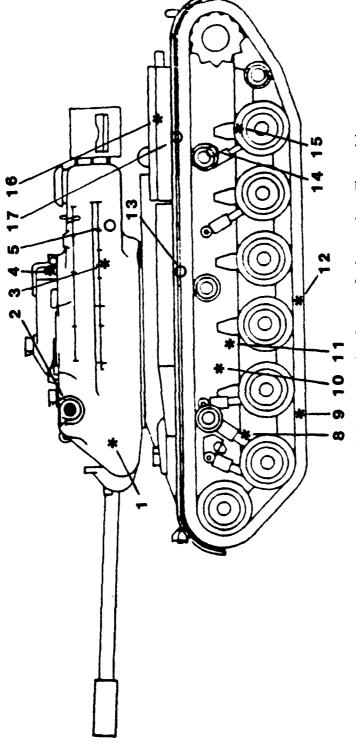
20% F-Kill resulting from the following impacts (Figure 29):

An assessment of a 20% F-Kill is based on impact 2 which perforated the left range finder blister and damaged the end housing assembly denying use of the range finder in determination of range to target (Figure 30).

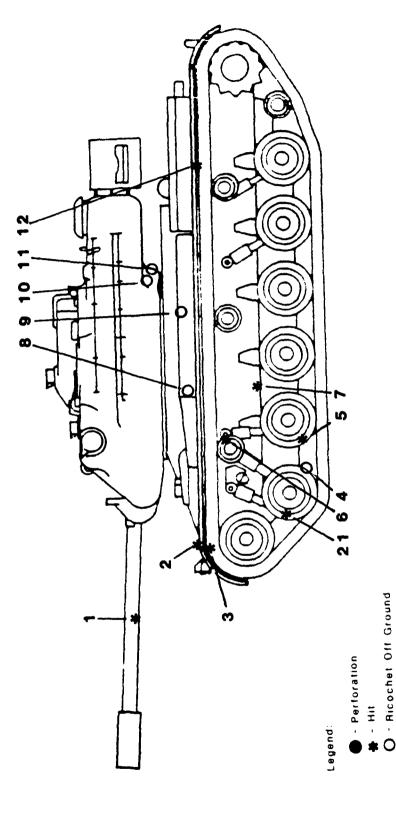
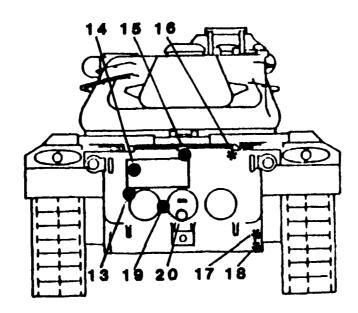
100% M-Kill resulting from the following observed effects (Figures 31 and 32):

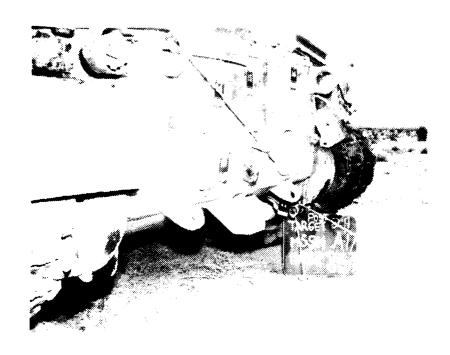
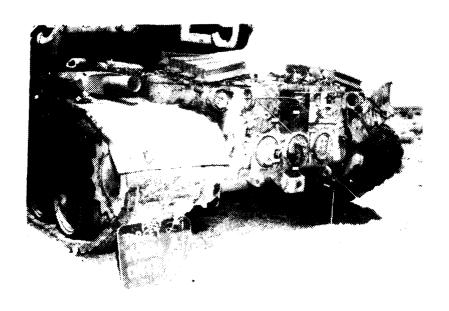
The assessment of 100% M-Kill is based on impacts 13 and 19 (Figures 33 and 34) which perforated the rear of the hull and penetrated into the transmission case. The resulting effects on the transmission, i.e., loss of transmission oil and fragment and spall damage to gears, would result in complete loss of function of the transmission and immobilization of the tank.

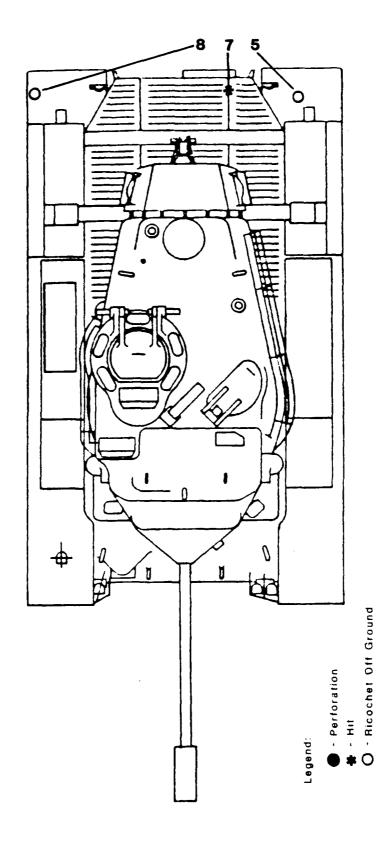
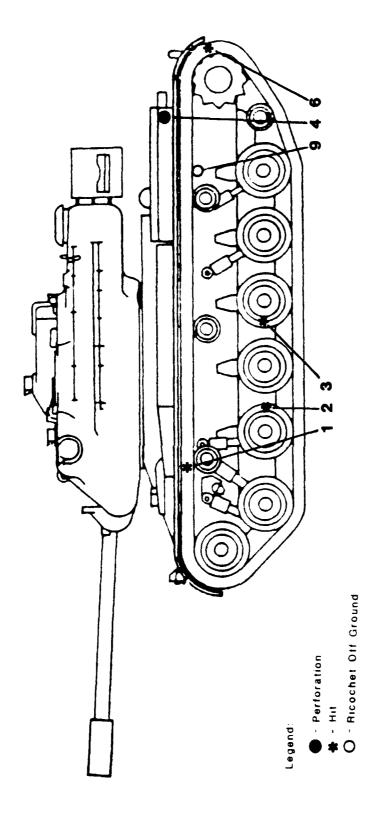
100% M-Kill resulting from the following observed effects (Figures 35 and 36):

This tank was observed to be a delayed burn, probably caused by impact 4 which perforated the left hull into the engine compartment penetrating an oil cooler line and a valve cover, apparently igniting a small fire which spread into a killing fire.

Since there were no crew casualties the CDAT assumed that the crew could have controlled a small grease or oil fire thereby limiting damage to a mobility kill.
